Manhole Inspection Summary

Manhole # S41K__002MH

Insp Date: **11/25/08 12:53 PM**

Location Address: **701 alicenna st**

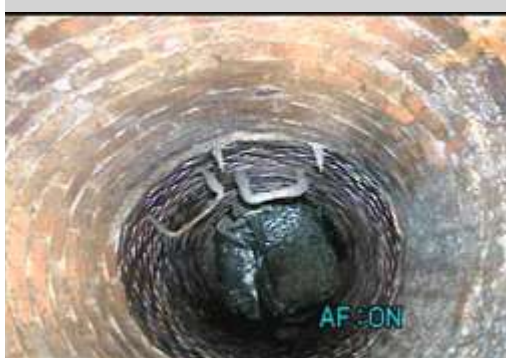
Defect 1

Count: **9** Missing: **3** ☒ **Corroded**

corr steps

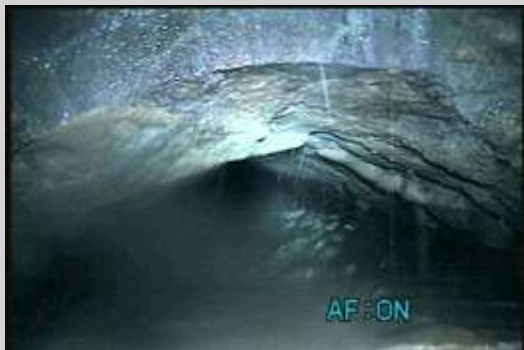
12 O'Clock Outflow

60 in. Circular Gravity Sewer
Pipe Out @ 12 O'Clock

Pipe Material: **Concrete** ☐ Pipe Lined

Invert Depth: **22.41** (ft.) Flow Characteristics: **Fast**

Infiltration: **None** Pipe Seal Cond: **Unknown**

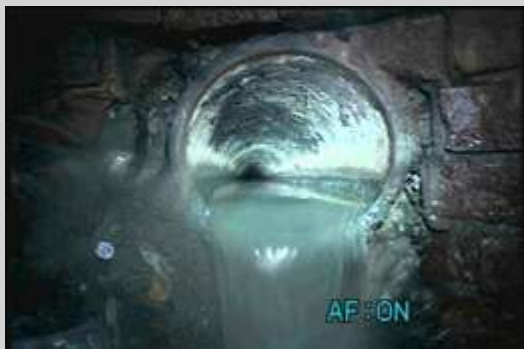
4 O'Clock Inflow

8 in. Circular Gravity Sewer
Pipe In @ 4 O'Clock

Pipe Material: **Clay** ☐ Pipe Lined

Invert Depth: **14.75** (ft.) Flow Characteristics: **Fast**

Infiltration: **None** Pipe Seal Cond: **Unknown**

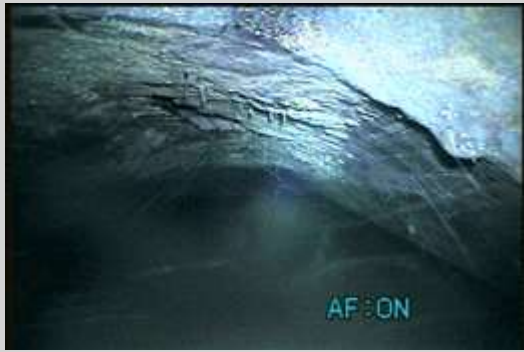
6 O'Clock Inflow

60 in. Circular Gravity Sewer

Pipe In @ 6 O'Clock

Pipe Material: **Concrete** ☐ Pipe Lined

Invert Depth: **22.25** (ft.) Flow Characteristics: **Fast**

Infiltration: **None** Pipe Seal Cond: **Unknown**

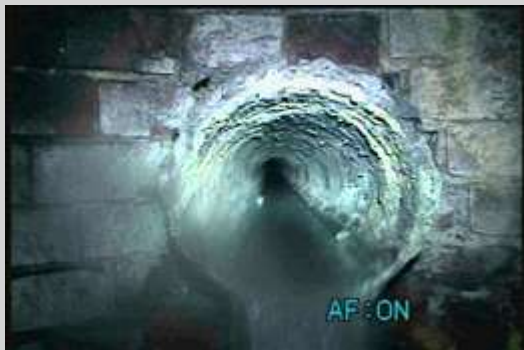
9 O'Clock Inflow

8 in. Circular Gravity Sewer

Pipe In @ 9 O'Clock

Pipe Material: **Clay** ☐ Pipe Lined

Invert Depth: **11.83** (ft.) Flow Characteristics: **Fast**

Infiltration: **None** Pipe Seal Cond: **Unknown**
